DEPARTMENT OF TRANSPORTATION

Contract #: 04-0120F4Cty: SF/ALA Rte: 80 PM: 13.2/13.9File #: 69.28**WELDING INSPECTION REPORT****Resident Engineer:** Pursell, Gary**Address:** 333 Burma Road**City:** Oakland, CA 94607**Report No:** WIR-006466**Date Inspected:** 21-Apr-2009**Project Name:** SAS Superstructure**OSM Arrival Time:** 1845**Prime Contractor:** American Bridge/Fluor Enterprises, a JV**OSM Departure Time:** 645**Contractor:** Zhenhua Port Machinery Company, Ltd (ZPMC), Changxing Island **Location:** Shanghai, China**CWI Name:** See Below**CWI Present:** Yes No**Inspected CWI report:** Yes No N/A**Rod Oven in Use:** Yes No N/A**Electrode to specification:** Yes No N/A**Weld Procedures Followed:** Yes No N/A**Qualified Welders:** Yes No N/A**Verified Joint Fit-up:** Yes No N/A**Approved Drawings:** Yes No N/A**Approved WPS:** Yes No N/A**Delayed / Cancelled:** Yes No N/A**Bridge No:** 34-0006**Component:** TOBG and Tower Fabrication**Summary of Items Observed:**

WELDING INSPECTION REPORT

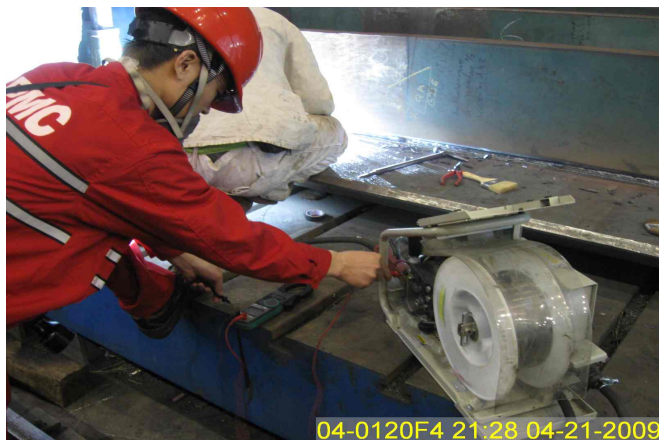
This QA Inspector observed ZPMC welder Mr. Chang Hai Xia, stencil 045209 is using flux cored welding procedure WPS B-T-2213-B-U3-F to make OBG Segment 2C weld 36. The QA Inspector observed a welding current of 240 amps and 34 volts. The welding procedure specification maximum voltage limit is 32 volts and this welding voltage is above the maximum limit. The QA Inspector showed QC Inspector Mr. Pan Wen long this welding voltage and Mr. Pan Wen long adjusted the welding voltage to approximately 31 volts prior to additional welding. The QA Inspector also informed CWI Mr. Shi Lin that the QA Inspector had observed a high voltage. Items observed by this QA Inspector do not appear to be fully progressing in compliance with project specifications. See the photograph below showing Mr. Pan Wen long adjusted the welding voltage.
